Manhole Inspection Summary

Manhole # S11WW1005MH

Insp Date: **7/24/06 2:24 PM**

Location Address: **2420 W ROGERS AVE**

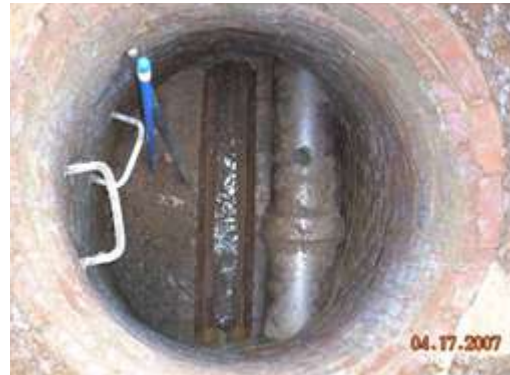
Top View

Evidence of surcharge - Bench debris.
Abandoned storm sewer pipe?

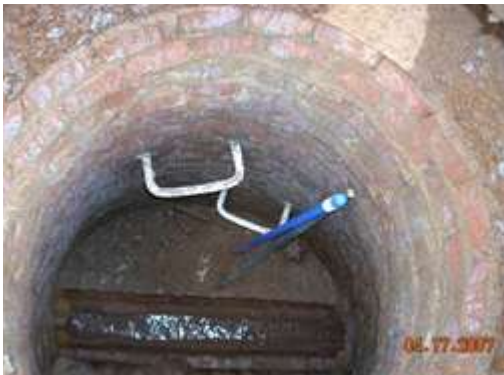
Defect

Frame leaks. Adjustment deterioration
and infiltration. Corbel and Barrel
infiltration.

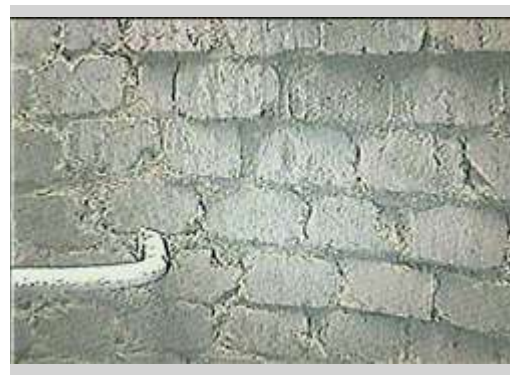
Defect

Corbel and Barrel deterioration and
infiltration.

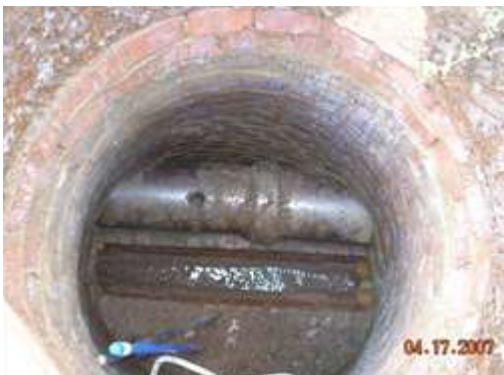
Defect

Frame leaks. Adjustment deterioration
and infiltration. Corbel and Barrel
infiltration - other side.

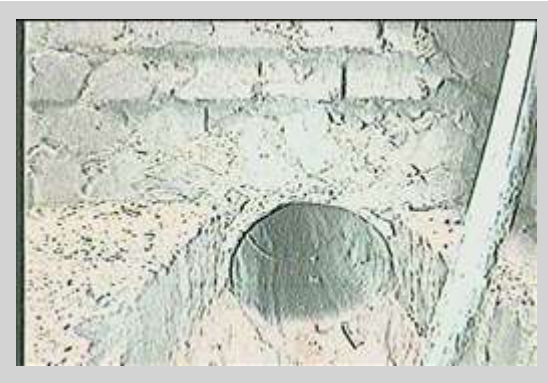
Pipe Out @ 12 O'Clock

Barrel deterioration and infiltration.

Infiltration: **None** Pipe Seal Cond: **Cracked**

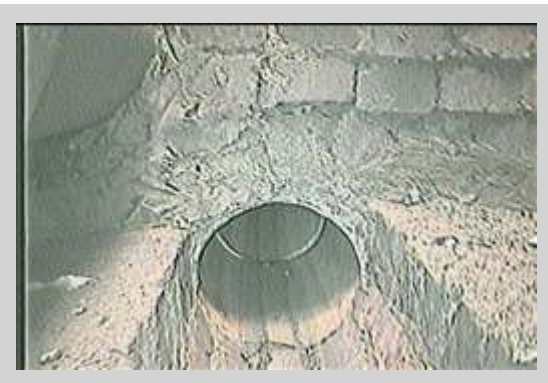
Pipe In @ 6 O'Clock

Barrel deterioration and infiltration. Channel deterioration.
